CITY OF MARLIN

WASTEWATER TREATMENT PLANT

ASSET MANAGEMENT PLAN

(FALLS COUNTY, TEXAS)

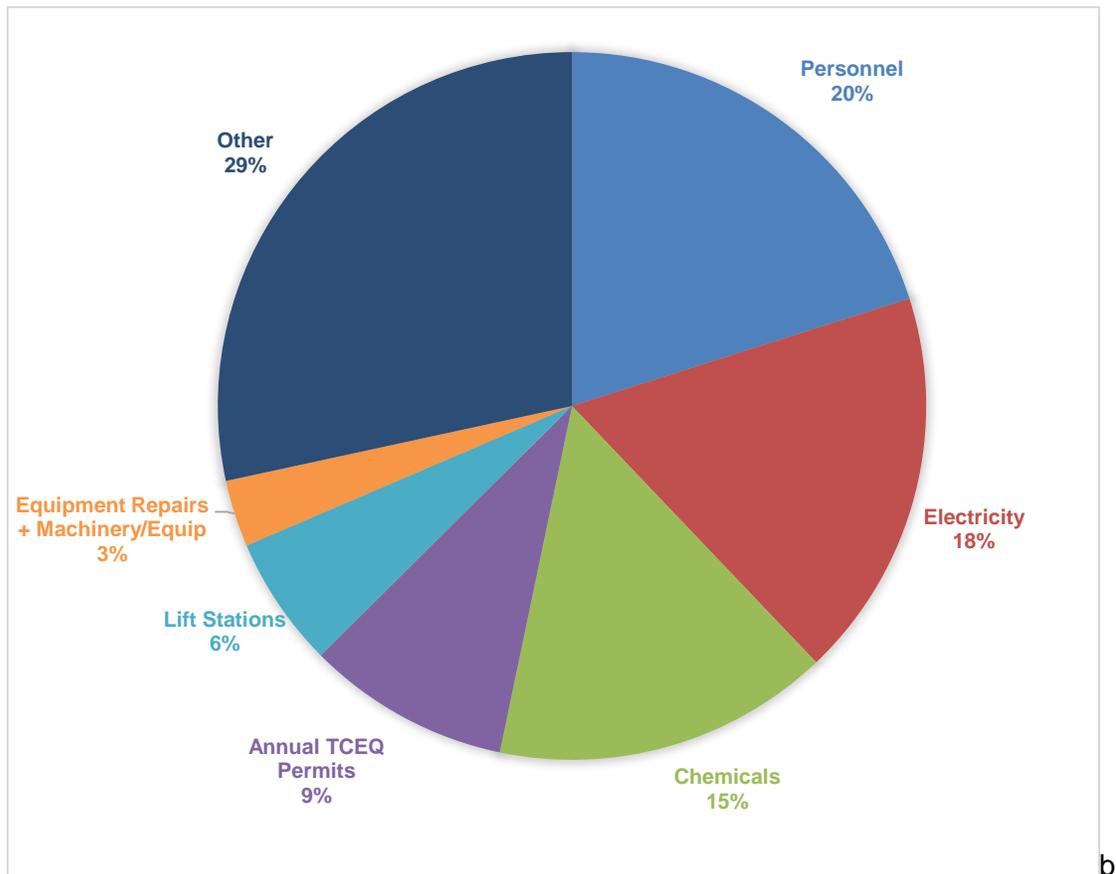
Figure 2. Sewer Expenditures (2011-2014)

Budget Item	Average (2011- 2014)	Percent Total
Personnel	\$92,140	20.1%
Electricity	\$81,661	17.8%
Chemicals	\$70,569	15.4%
Annual TCEQ Permits	\$42,552	9.3%
Lift Stations	\$27,498	6.0%
Equipment Repairs + Machinery/Equip	\$14,013	3.1%
Other	\$130,258	28.4%
<i>Total</i>	<i>\$458,690</i>	<i>100.0%</i>

In order to arrive at a minimum life cycle cost for the WWTP, the current expenditures were analyzed. From the accounting software, the city was able to provide a list of expenditures based on the budgeted items. This review studies the actual expenditures. On average, the city has been spending \$459,000 per year on the wastewater treatment plant and sewer system expenditures. Table 6 and Figure 2 reveal the major expenditures at the WWTP and sewer system. Table 7 presents the detailed budgeted items.

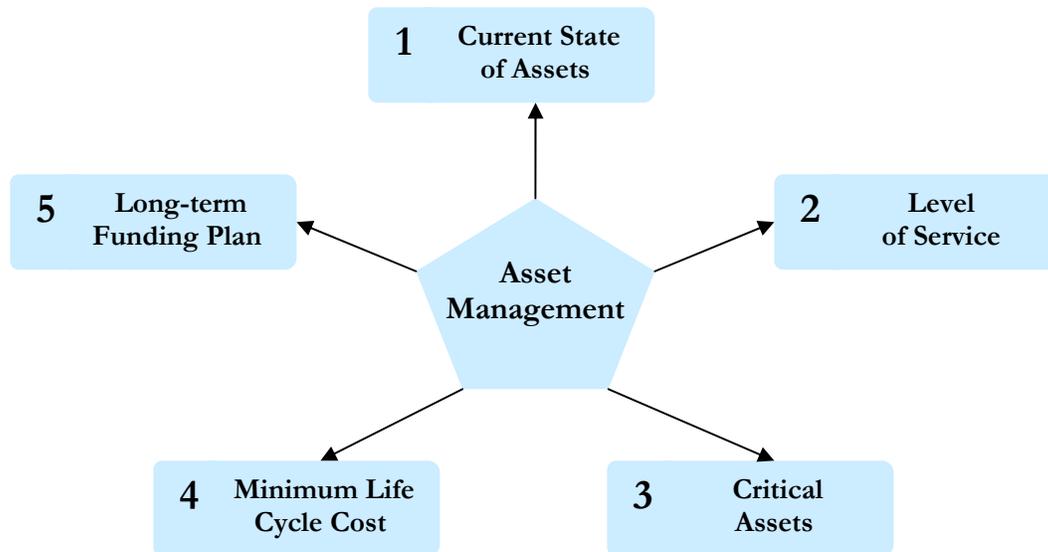
Flow Chart: The Five Core Questions of Asset Management Framework

This flow chart shows the relationships and dependencies between each core framework question.

A good starting point for any size water system is the five core questions framework for asset management. This framework walks you through all of the major activities associated with asset management and can be implemented at the level of sophistication reasonable for a given system. These five core framework questions provide the foundation for many asset management best practices. Several asset management best practices are listed for each core question on the following pages. Keep in mind that these best practices are constantly being improved upon.
